Collapse of the World Trade Center Towers

Written by G Charles Clifton,
HERA Structural Engineer

17th September 2001 and revised 19th September.

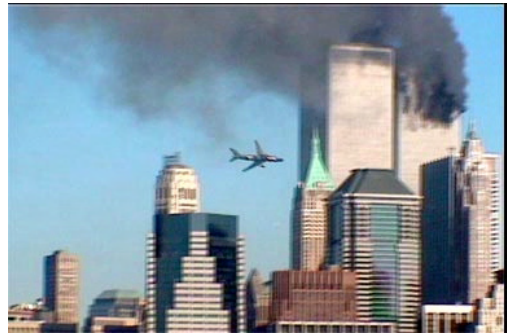
Fig. 8
Plane About to Hit South Tower
(Photo from CNN)

Each tower was hit by a Boeing 767. The impact on the North tower was near the center of the North face at around the 95th storey, with the plane hitting the side of the building square on and flying level. The impact on the South tower was some 15 storeys lower, with the plane hitting the South face near the South East corner and impacting at an angle to the face of the tower. Fig 2 shows the impact directions and Fig 8 shows the plane about to hit the South Tower.

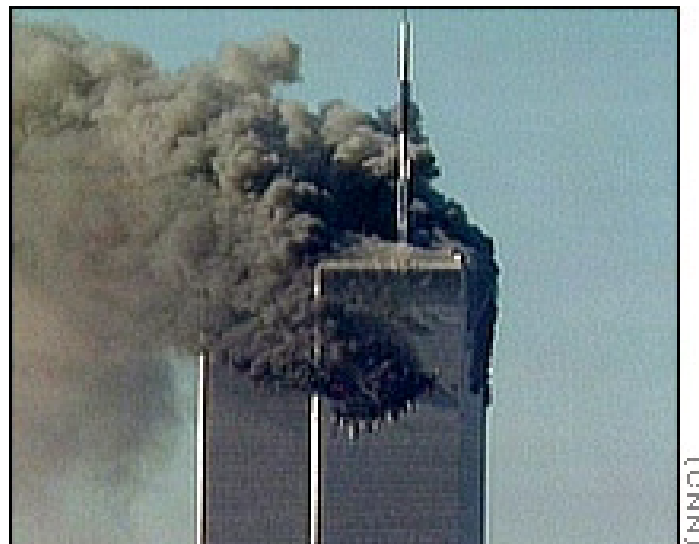
Fig. 9
North Tower After Impact Viewed From the Impact Side
(Photo from CNN)

Fig 9 shows the view looking into the impact hole. Given that the floor slabs are at 3.66 m centers and the façade column centers are at 1.03 metre centers with façade window widths of only 0.48 m, the number of façade columns and perimeter beams severed by the airplane in its passage though the perimeter frame is considerable. From the major damage to the side opposite the impact it is also apparent that much of the airplane would have passed through the core. It is likely that the impact destroyed most of the floors, at least on the impact side, and the core on at least three levels, removing many of the core supporting columns, at least on the North side of the core, and leaving the remainder buckled and stripped of their passive fire protection. This would have caused the floors above the impact level to sag

downwards in the center, with the gravity columns above the impact region now acting as tension ties between each of the upper floors, through to the top floor. Each upper floor would now have had to be at least partially supported off the perimeter frame. HERA has developed a method (based on UK fire research) allowing the design of unprotected secondary beams in composite floor systems by using the dependable inelastic reserve of strength from a region of floor slab supported around its perimeter. I have applied this in a very approximate manner to a typical WTC floor slab supported off only the perimeter frame and the result shows that this is just about possible with regard to the membrane capacity of the floor system, but not possible in terms of the vertical load carrying capacity of the connection between the floors and the perimeter frame. As the vertical load carrying capacity of the core diminished, requiring more load to be transferred from the floors to the perimeter frames, the mode of failure would have most likely been failure of this connection, leading to floor collapse.

I contend that, immediately following the impact, the core region of all the floors above the impact region would have sagged downwards due to the loss of vertical support in the core region. This sag would have progressively grown as the fire and ongoing yielding of the remaining damaged core columns reduced the core vertical load carrying capacity. This would have placed severe overstress on the connection between floor and perimeter frame around each floor at every level, with the greatest effect at the top floor, due to the core columns interconnecting each floor above the impact region now acting as tension ties. This would also have put extra vertical load on the perimeter frames, however these are sized to resist the lateral loading and would have had more than sufficient capacity to resist this extra load, especially as it would have distributed itself symmetrically around the perimeter frames.

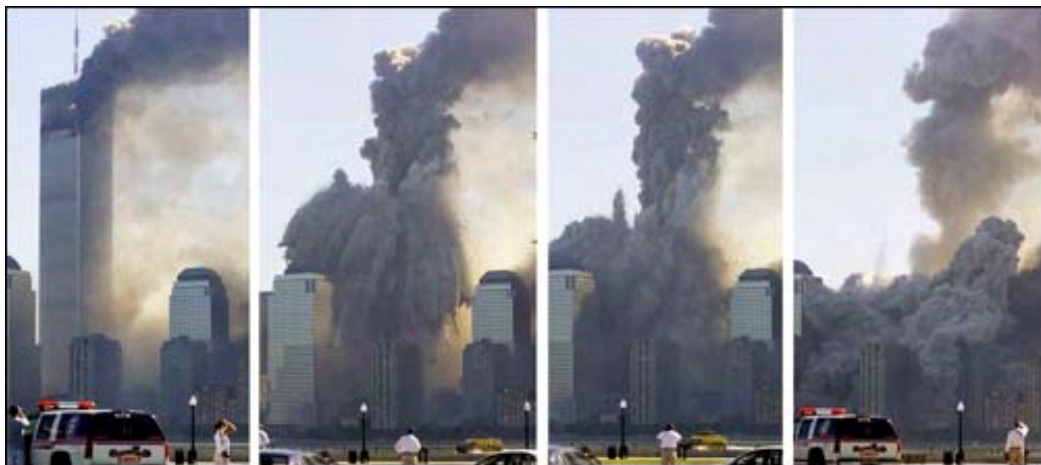
Fig. 10
Sequence of Collapse of North Tower
(Photo from CNN)

Finally, it is likely that the interconnection between one or more floors and the perimeter frame failed at or near the top of the building. This would have resulted in the immediate collapse of these floors. From the video footage this collapse appeared to occur uniformly around the building and spread very rapidly down to the floor above the impact region. That region then pancaked causing a brief gout of flame to be expelled most noticeably from around the South and East sides as the areas within the impact region still on fire collapsed.

The collapse then continued down the building, with the floors pancaking leaving the perimeter frames briefly standing unsupported until they too collapsed. The effect of the floors pancaking nearly straight down inside the perimeter frames lead to the North tower effectively imploding, with some sections of the perimeter frame remaining standing unsupported for a few seconds before collapsing. This is seen from a number of video footages and pictures, including the collapse sequence shown in Fig 10.

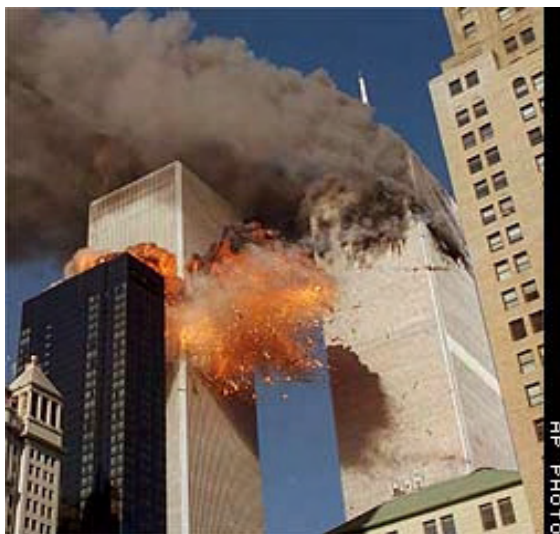
Fig.11

At 9.03 am the plane impacted the South side of the south tower towards the South East corner. It struck the building at an angle across that corner and on a slight downwards heading, as shown in Fig.2. The plane passed into the building and then exploded out of the adjacent East side, causing a large fireball to erupt from both the entry and exit sides adjacent to the South East corner. Fig. 8 shows the plane immediately before impact and Fig 11 shows the expanding fireball erupting from both sides of the building.

In contrast to the North Tower impact, in the case of the South Tower only one corner of the core would have been directly in front of the plane's path through the building, along with the floor slabs over several levels in the South East corner. It is likely that the initial impact destroyed all the floor slabs in that corner over at least four levels and maybe over as many as six. It would have also severely damaged the South East corner core, removing an unknown number of columns there, buckling many more and destroying most of the

Immediately after the impact the perimeter frame in the South East corner would have been severely weakened, being reduced to an unknown number of intact box columns in towards that corner on each of the two sides. However, these columns would have lost the lateral support from the floor slabs over many levels and would have had to function as isolated columns spanning multiple storey heights. They would likely have suffered blast damage and loss of alignment, however immediately following the impact they still retained sufficient compression capacity to resist their share of the loads from the 30 or so floors above the impact region.

Fireball From Impact on South Tower
(Associated Press photo)

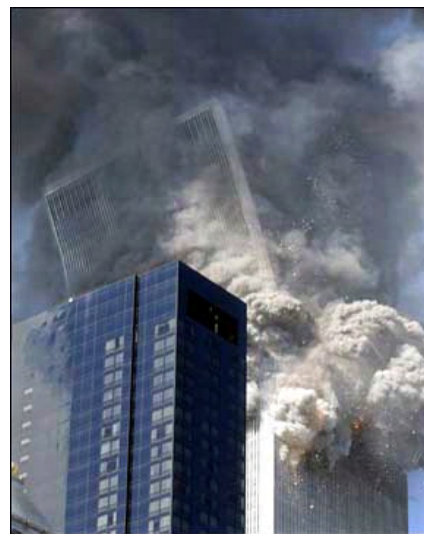
Fig.12

Top of South Tower Collapsing
(Photo from CNN)

Finally the combination of increasing compression load on these damaged columns, with second order effects from this load acting on the buckled shape of these columns over their unsupported length, would have caused their collapse. This collapse would have initiated in the damaged corner and spread rapidly over the impact region, causing the tower above to fail by toppling sideways with the floors above the impact region momentarily in an intact condition. This stage of the collapse is shown in Fig. 12.

However, even with the top floors toppling sideways, sufficient material would have impacted straight down on the floors below the impact region to have caused these to start to pancake downwards, leading to the tower below the impact region collapsing in much the same manner as the North tower.
