Collapse of the World Trade Center Towers

Written by G Charles Clifton,
HERA Structural Engineer

17th September 2001 and revised 19th September.

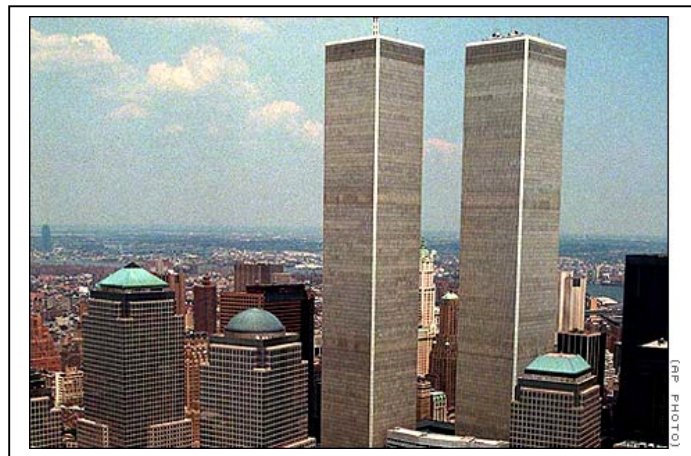
Fig 1
World Trade Center Towers Before Attack
(Associated Press photo)

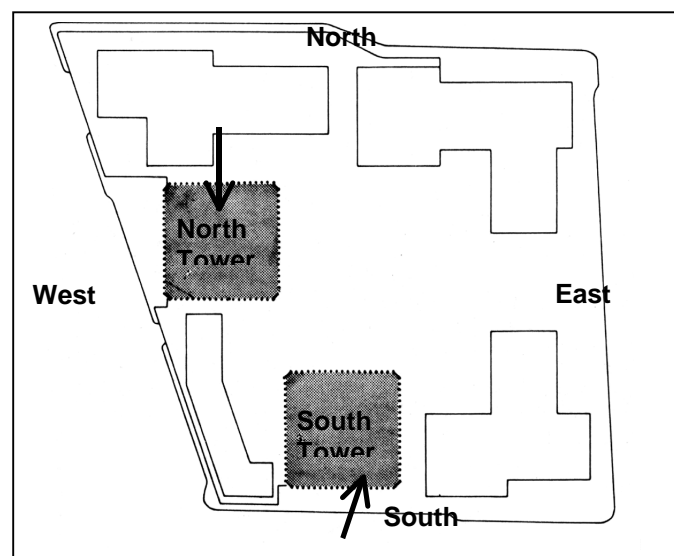
Fig. 2
Site Plan of World Trade Center Development Showing Location of the
Two Towers

(The direction of arrows adjacent to each tower shows the approximate direction of the planes on impact)

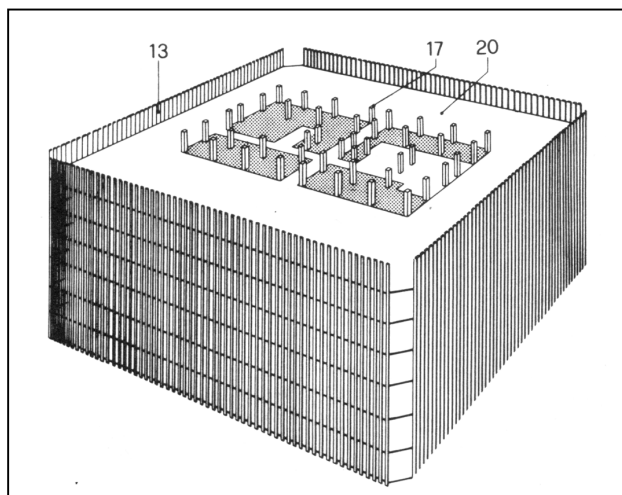
Fig. 3
Isometric View of Building
(from [1])

The numbers in the figure are taken from [1] and denote:
13 – Perimeter frame
17 – Core box columns 450 mm square
20 – Floor slab

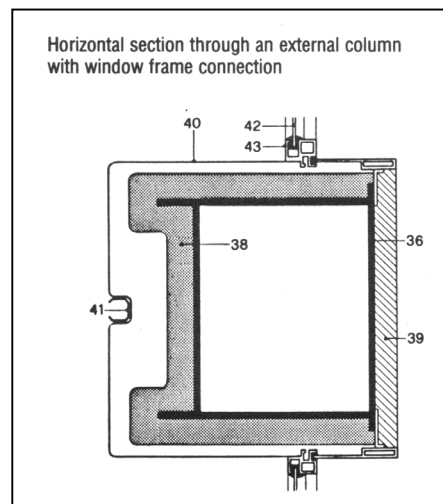
Fig. 4
Cross Section Through
Exterior Box Column (from [1])

The numbers in the figure are taken from [1] and denote:
36 – Steel column
38, 39 – Fire resistant plaster
40 – Aluminium façade
42 – Window glass
43 – Window frame
